# Cultural Heritage Report: Existing Conditions

## Barrie Collingwood Railway Active Transportation Trail Municipal Class Environmental Assessment

### County of Simcoe, Ontario

#### Draft Report

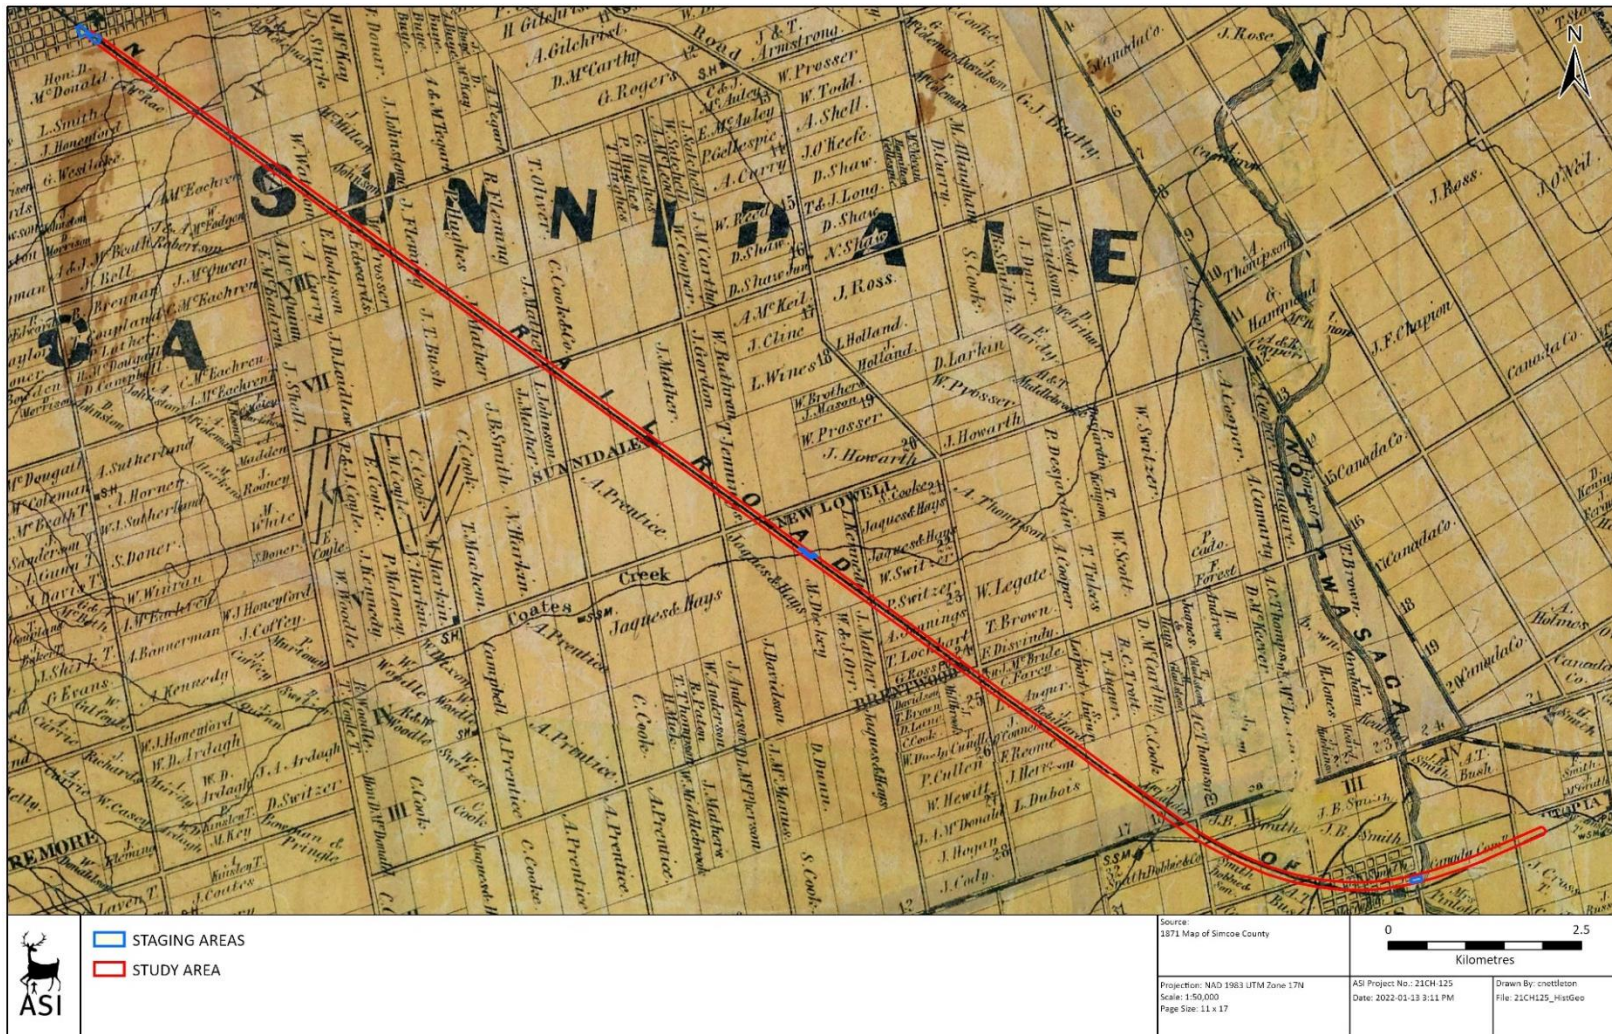
Figure 3: The study area overlaid on the 1871 Hogg's Map of the County of Simcoe. Base Map: (Hogg, 1871).

(O.S.& H.U.) Railroad) in a general rural agricultural context with the village of Stayner at the northern end of the study area and the village of Angus at the southern end (Figure 3 and Figure 4). The nineteenth-century mapping depicts the Northern Railway following the present alignment of the former rail line traveling in a general northwest-southeast direction from Stayner to Angus with the route curving eastwards to a northeast-southwest alignment east of Angus. The 1871 *Map* (Figure 3), shows the planned streets of Stayner laid out in a grid formation, with the railway line cutting through town diagonally. From west to east the railroad travels through Stayner, Sunnidale, New Lowell, Brentwood, and Angus. The study area ends between the communities of Angus and Utopia. In this section, the Nottawasaga River intersects with the study area on the west side of Angus. Around the midpoint of the study area another smaller waterway, Coates Creek, crosses the study area. The Mad River and the Pine River are also depicted; however, no bridges are illustrated at any of the crossings. Many parcels of land in this settler system have been identified with the 1871 property owner, however many blank parcels of land are visible on this map. Many of the historically surveyed roadways follow the boundaries of the created by the lot and concession system. The 1881 *Atlas* (Figure 4) identifies less historic features than the 1871 *Map*. A railway station is illustrated in the village of Sunnidale, the community of New Lowell now has planned streets, the planned community of Warrington is identified in lots 22 and 23 to the southwest of Stayner and the village of Brentwood now has a post office and a church identified northeast of the study area.

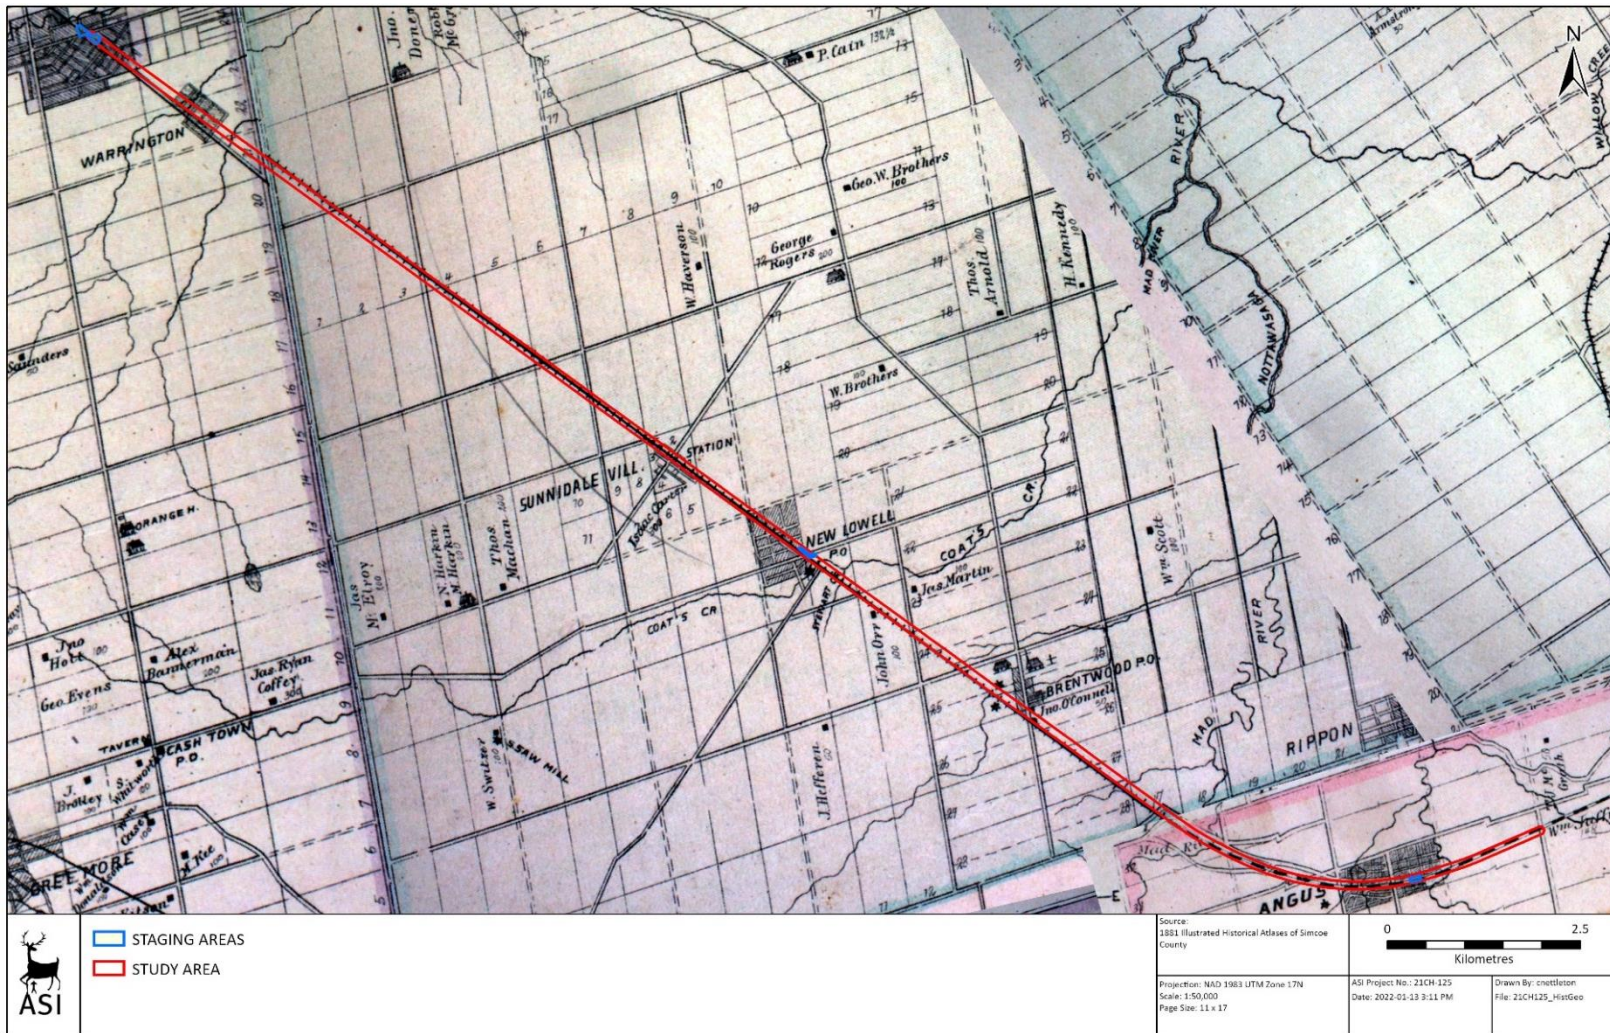
Figure 4: The study area overlaid on the 1881 Illustrated Historical Atlas of the County of Simcoe. Base Map: (Belden, 1881).

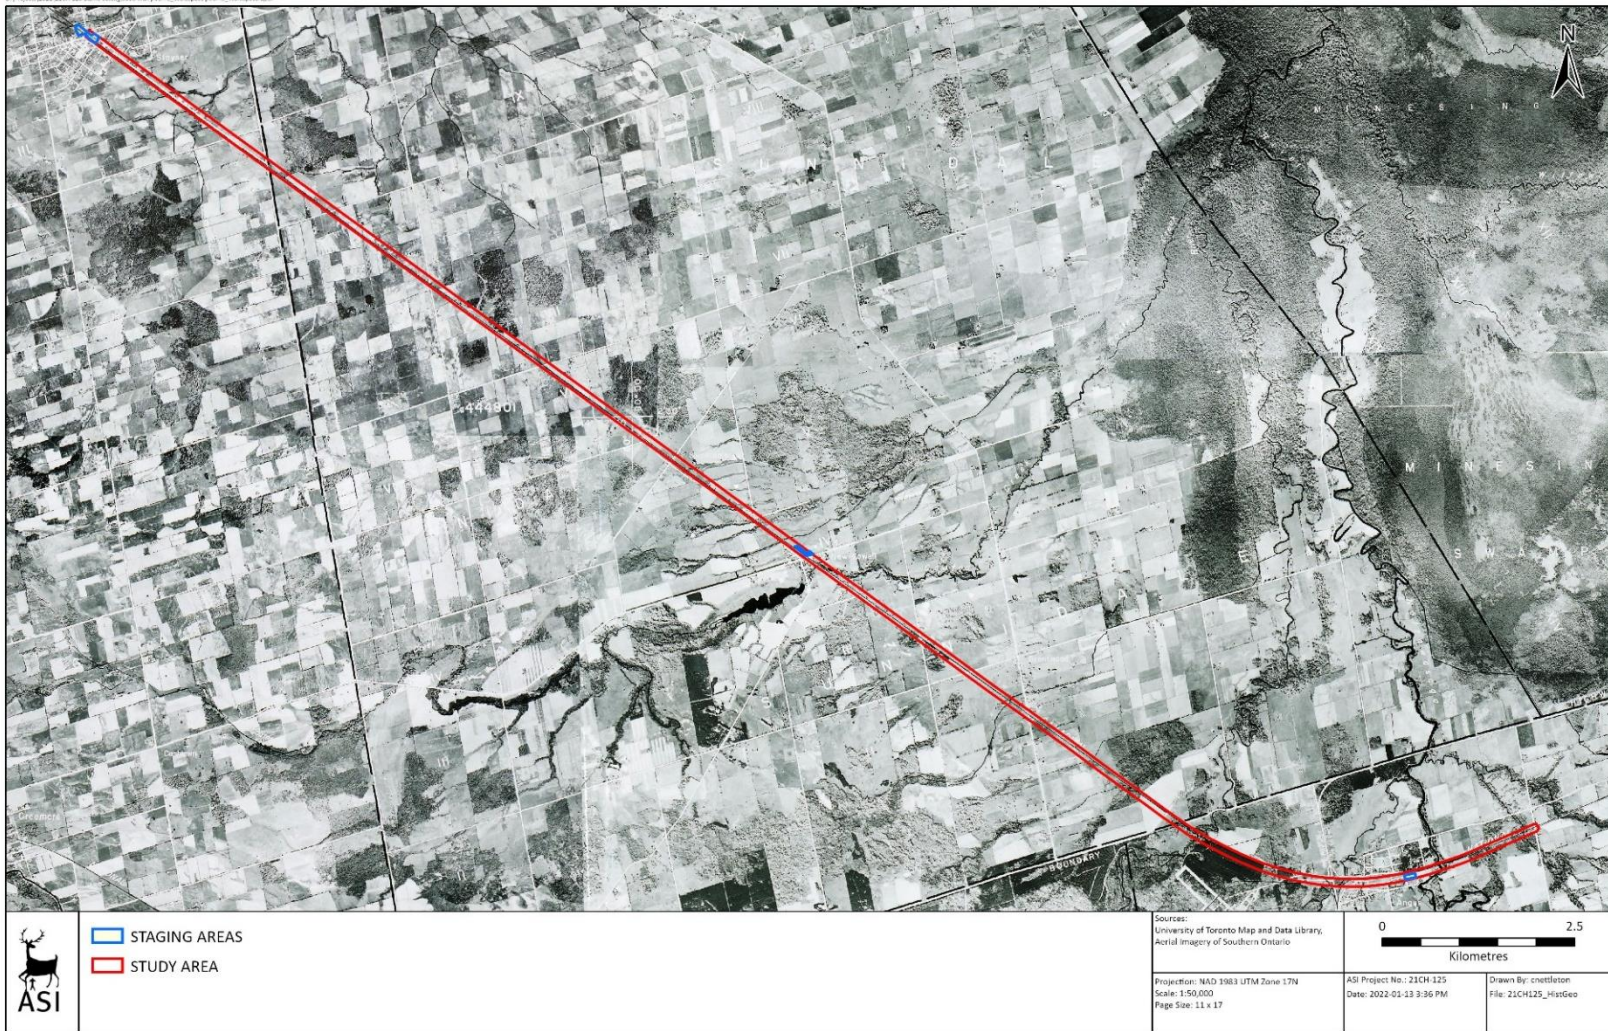
The 1954 aerial photograph (Figure 6) captures the study area in a similar context with large open agricultural fields and farmsteads, with some forested areas seen near creeks and tributaries. The villages of Stayner and Angus stand out in the aerial as their street layout is clearly seen. Angus has also undergone some development to the north of the rail corridor. Throughout the study area meandering tributaries are visible passing through the railway corridor. Few changes to the study area occur overall through the latter half of the twentieth-century.

Figure 6: The study area overlaid on the 1954 aerial photographs of the County of Simcoe. Base Plates: (Hunting Survey Corporation Limited, 1954).

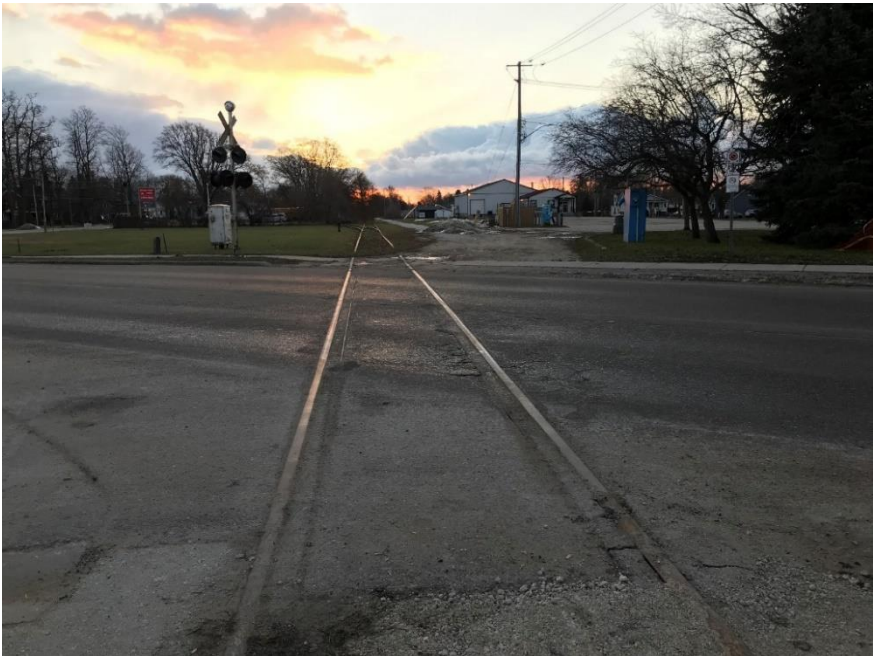
Plate 1: Looking southeast along the former railway in Stayner at the northern end of the study area.

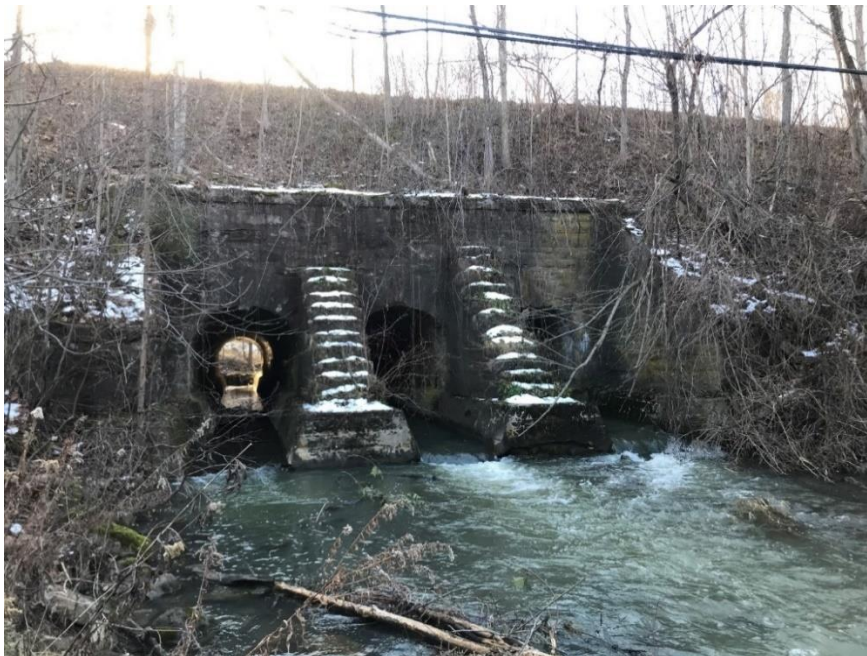
Plate 8: View of the New Lowell stone arch culvert, looking west.

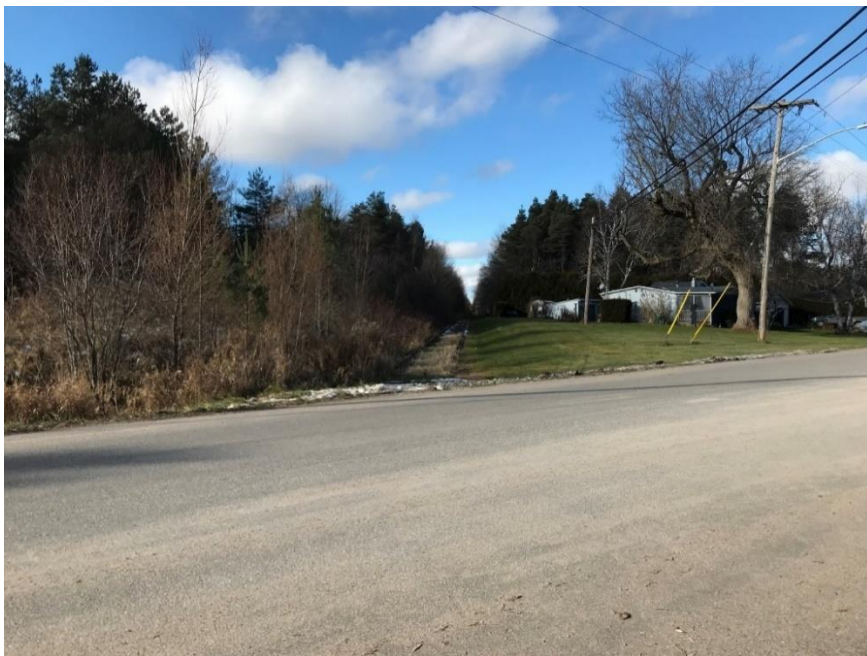
Plate 10: View of the former rail line, looking northwest from McCarthy Drive.

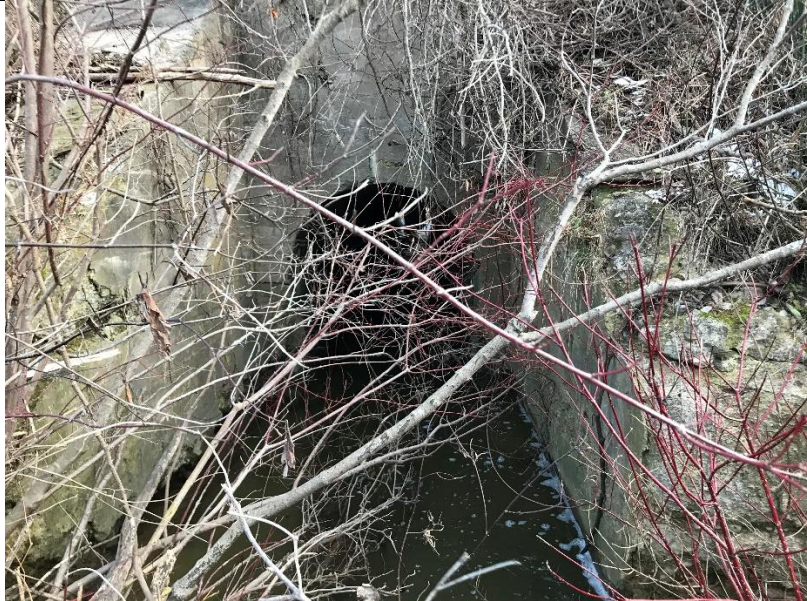
Feature I.D.	Type of Property	Address or Location	Heritage Status and Recognition	Description of Property and Known or Potential C.H.V.I.	Photographs/ Digital Image
B.H.R. 1	Culvert	Former Ontario, Simcoe and Huron Union Railroad (O.S. and H.U.) at Warrington Creek	Potential B.H.R. – Identified during desktop review and/or field review  Identified during field review	The culvert is located along the former rail line, carrying Warrington Creek under the rail line southeast of Stayner. The potential heritage attributes include the concrete arch culvert along the former rail line. The 1871 map (Figure 3) depicts the rail line over the creek.  The 1907 G.T.R. Inventory notes a culvert in this approximate location as the Mile 84.96 stone arch culvert, a 5 foot by 8 foot structure constructed in 1863 (GTR, 1907).

<p data-bbox="2110 1030 2738 1064">Plate 20: View of the concrete arch culvert.</p>

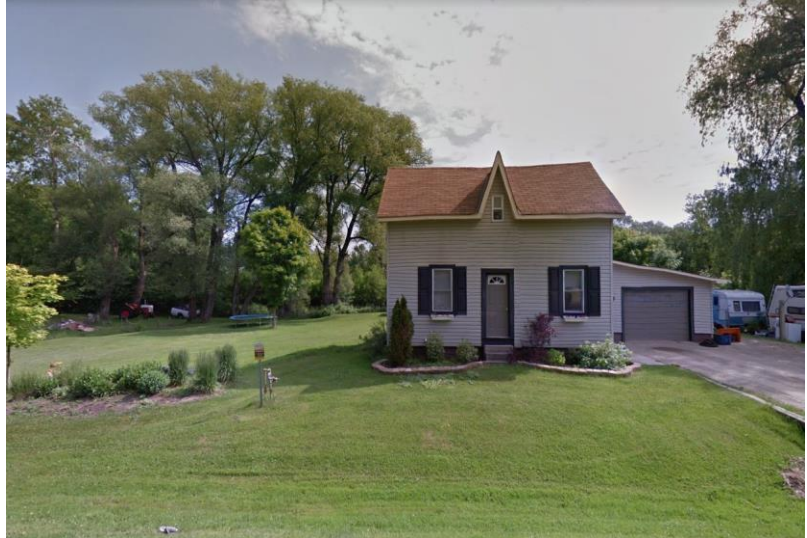
B.H.R. 2	Residence	125 Switzer Street	Potential B.H.R. – Identified during desktop review and/or field review  Identified during a review of Google Streetview	The residence is located along the eastern side of Switzer Street to the south of Creemore Avenue. The potential heritage attributes include the one-and-a-half storey house with gable roof and central gable. The house features a symmetrical front façade with a central doorway and windows. The 1940 and 1941 topographic map (Figure 5) depicts a residence in the vicinity of the extant structure.

<p data-bbox="2110 1614 2878 1687">Plate 21: View of the residence at 125 Switzer Street (Google Streetview 2015).</p>

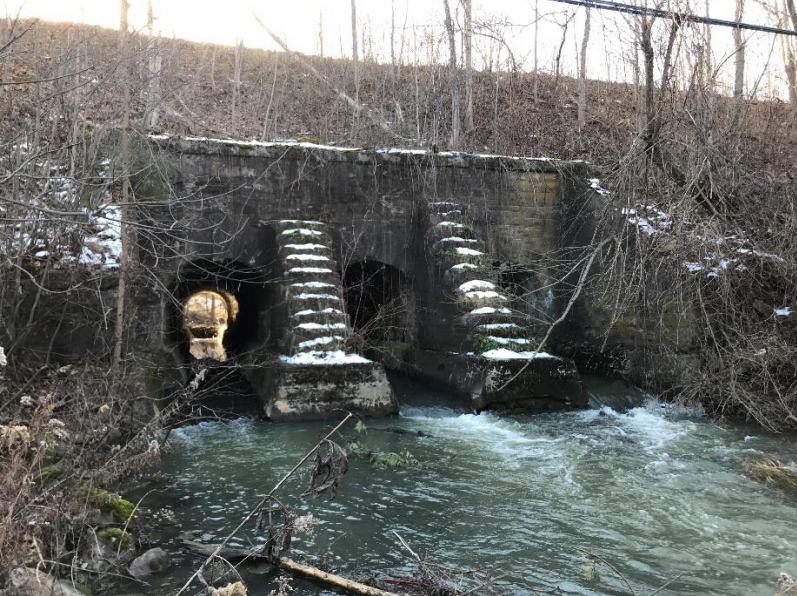
Feature I.D.	Type of Property	Address or Location	Heritage Status and Recognition	Description of Property and Known or Potential C.H.V.I.	Photographs/ Digital Image
B.H.R. 3	Culvert	Former O.S. and H.U. at Coates Creek	Potential B.H.R. – Identified during desktop review and/or field review  Identified during field review	The culvert is located along the former rail line, carrying Coates Creek under the rail line in New Lowell. The potential heritage attributes include the stone arch culvert along the former rail line. The 1871 map (Figure 3) depicts the rail line over the creek. The 1907 G.T.R. Inventory notes a culvert in this location as the Mile 78.70 stone arch culvert, a three vault 8 foot by 8 foot structure constructed in 1863 (GTR, 1907).

<p data-bbox="2116 963 2738 993">Plate 22: View of the concrete arch culvert.</p>
B.H.R. 4	Residence	5185 Concession 3 Sunnidale	Potential C.H.L. – Identified during desktop review and/or field review  Identified during a review of Google Streetview	The residence is located near the southeastern end of Concession 3 Sunnidale. The potential heritage attributes include the one-and-a-half storey residence with a gable roof, centre gable, and a saltbox rear addition. The front façade features a covered verandah, central door, and symmetrical windows on both the first and second floors. The 1881 map (Figure 4) depicts a residence in the vicinity of the extant structure.

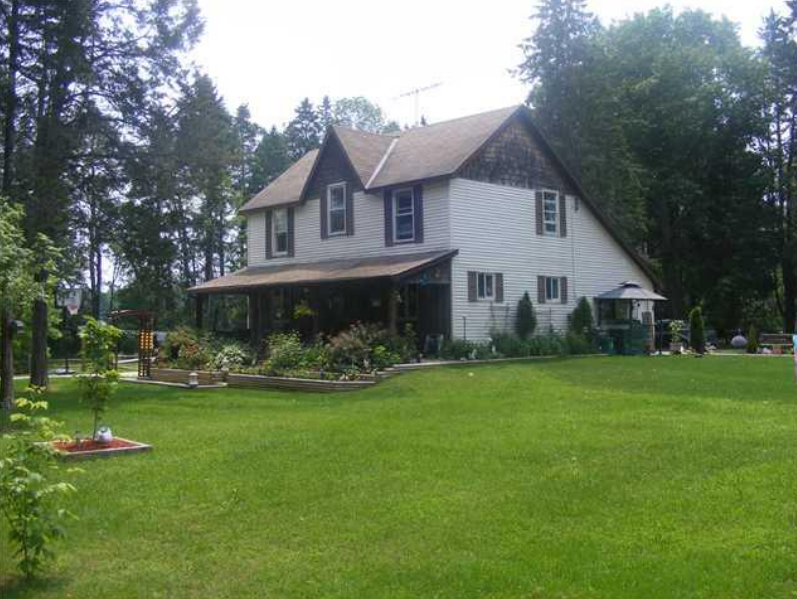
<p data-bbox="2116 1584 2874 1657">Plate 23: View of the residence at 5185 Concession 3 Sunnidale (Royal LePage, 2022).</p>

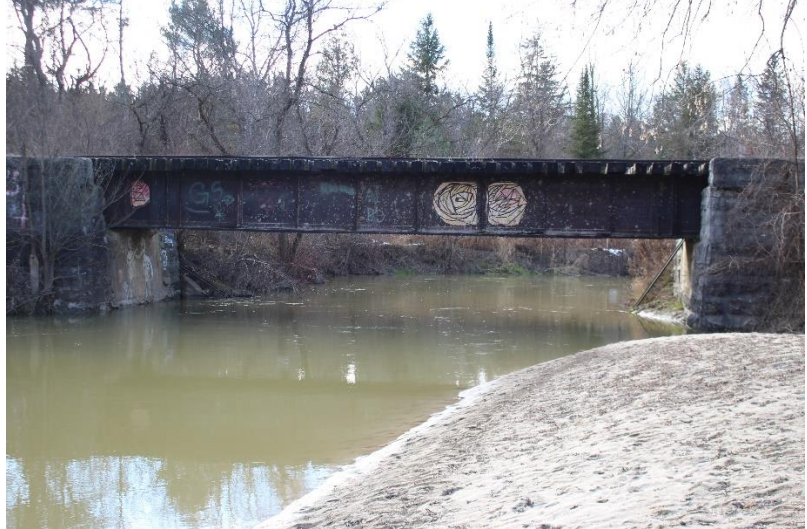
Feature I.D.	Type of Property	Address or Location	Heritage Status and Recognition	Description of Property and Known or Potential C.H.V.I.	Photographs/ Digital Image
B.H.R. 5	Bridge	Former O.S. and H.U. at Mad River	Potential B.H.R. – Identified during desktop review and/or field review  Identified during field review	<p>The bridge is located along the former rail line over the Mad River to the west of Angus. The potential heritage attributes include the single-span deck plate girder structure with masonry abutments along the former rail line. The 1871 map (Figure 3) depicts the rail line over the creek.</p> <p>This structure is being assessed in a Cultural Heritage Evaluation Report (ASI, 2022), that is being completed concurrently to this Cultural Heritage Report as part of the Barrie Collingwood Railway Active Transportation Trail project.</p>

<p>Plate 24: View of the Mad River bridge.</p>

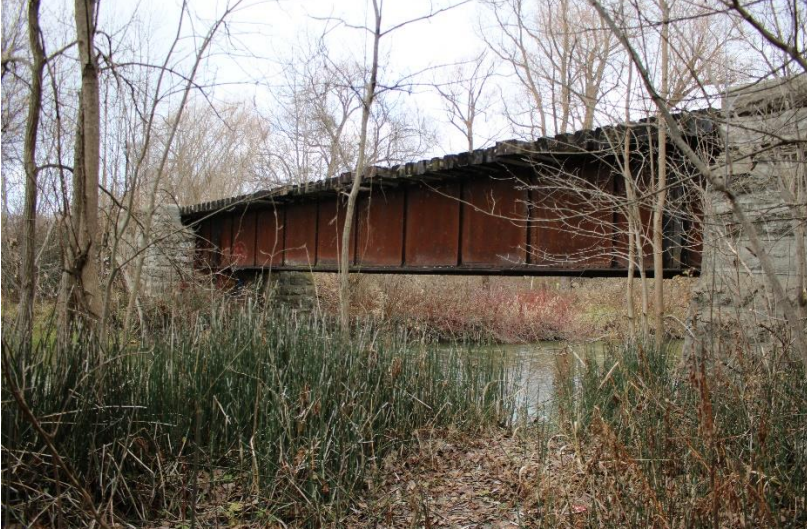
B.H.R. 6	Bridge	Former O.S. and H.U. at Pine River, Town of Angus	Potential B.H.R. – Identified during desktop review and/or field review  Identified during field review	<p>The bridge is located along the former rail line over the Pine River within Angus. The potential heritage attributes include the single-span deck plate girder structure with masonry abutments along the former rail line. The 1871 map (Figure 3) depicts the rail line over the river.</p> <p>This structure is being assessed in a Cultural Heritage Evaluation Report (ASI, 2022), that is being completed concurrently to this Cultural Heritage Report as part of the Barrie Collingwood Railway Active Transportation Trail project.</p>

<p>Plate 25: View of the Pine River bridge.</p>

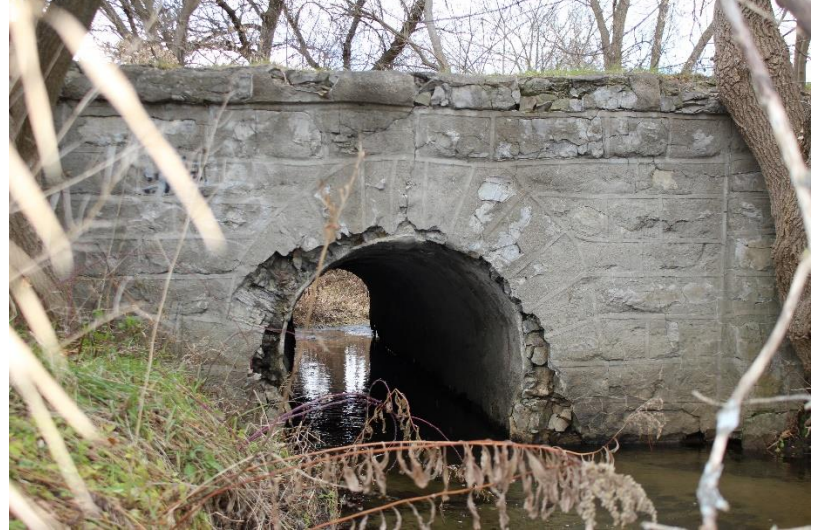
Feature I.D.	Type of Property	Address or Location	Heritage Status and Recognition	Description of Property and Known or Potential C.H.V.I.	Photographs/ Digital Image
B.H.R. 7	Culvert	Former O.S. and H.U. at a tributary of the Pine River near Cross Street, Town of Angus	Potential B.H.R. – Identified during desktop review and/or field review  Identified during field review	The culvert is located along the former rail line, carrying a tributary of the Pine River under Cross Street. The potential heritage attributes include the stone arch culvert along the former rail line. The 1871 map (Figure 3) depicts the rail line over the tributary.  The 1907 G.T.R. Inventory notes a culvert in this approximate location as the Mile 73.53 stone arch culvert, a 5 foot by 5 foot structure constructed in 1863 (GTR, 1907).

<p data-bbox="2107 903 2697 935">Plate 26: View of the stone arch culvert.</p>
B.H.R. 8	Residence	119 King Street	Potential B.H.R. – Identified during desktop review and/or field review  Identified during a review of Google Streetview	The residence is located at the northeastern corner of the intersection of King Street and Auburn Street. The potential heritage attributes include the one-and-a-half storey house with a gable roof and a single storey rear addition. The residence features a wrap-around covered verandah and a central door flanked by windows on both sides. The 1940 and 1941 topographic map (Figure 5) depicts a residence in the vicinity of the extant structure.

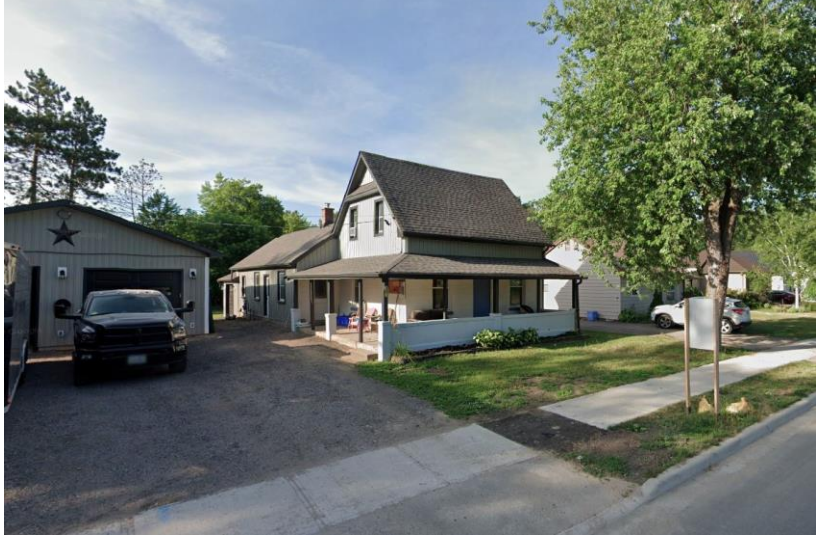
<p data-bbox="2107 1463 2831 1538">Plate 27: View of the residence at 119 King Street (Google Streetview 2019).</p>

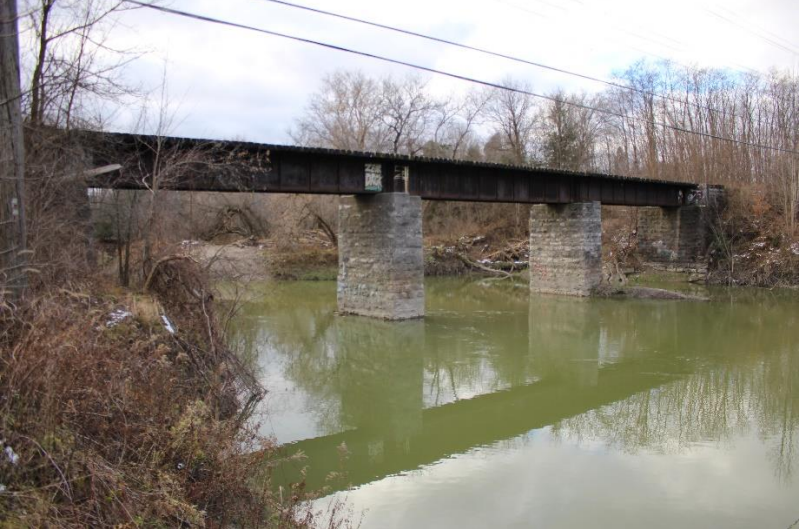
Feature I.D.	Type of Property	Address or Location	Heritage Status and Recognition	Description of Property and Known or Potential C.H.V.I.	Photographs/ Digital Image
B.H.R. 9	Bridge	Former O.S. and H.U. at Nottawasaga River, Town of Angus	<p>Potential B.H.R. – Identified during desktop review and/or field review</p> <p>Identified during field review</p>	<p>The bridge is located along the former rail line over the Nottawasaga River within Angus. The potential heritage attributes include the three--span deck plate girder structure with masonry abutments along the former rail line. The 1871 map (Figure 3) depicts the rail line over the creek.</p> <p>This structure is being assessed in a Cultural Heritage Evaluation Report (ASI, 2022), that is being completed concurrently to this Cultural Heritage Report as part of the Barrie Collingwood Railway Active Transportation Trail project.</p>

<p>Plate 28: View of the Nottawasaga River bridge.</p>

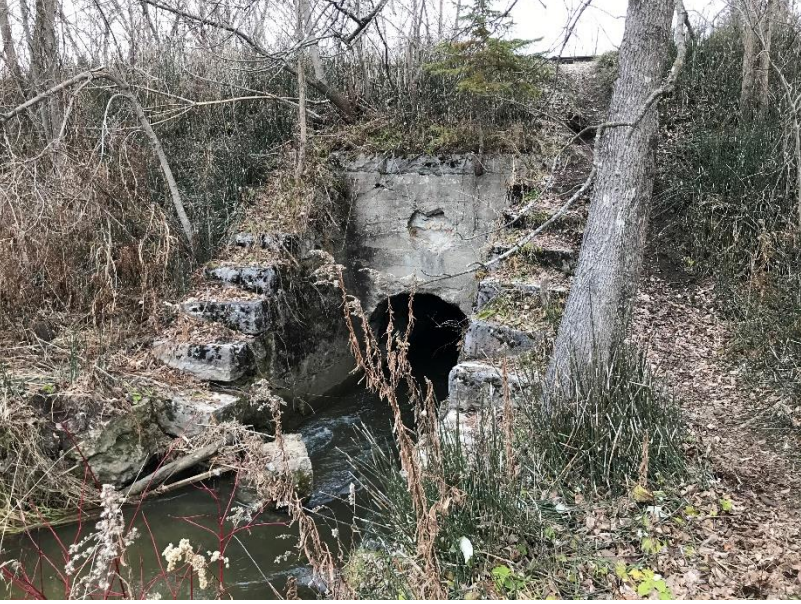
B.H.R. 10	Culvert	Former O.S. and H.U. at a tributary of the Nottawasaga River near Line 5	<p>Potential B.H.R. – Identified during desktop review and/or field review</p> <p>Identified during field review</p>	<p>The culvert is located along the former rail line, carrying a tributary of the Nottawasaga River under the former rail line to the west of Line 5 in Angus. The potential heritage attributes include the stone arch culvert along the former rail line. The 1871 map (Figure 3) depicts the rail line over the tributary.</p> <p>The 1907 G.T.R. Inventory notes a culvert in this approximate location as the Mile 72.18 stone arch culvert, a 5 foot by 5 foot structure constructed in 1863 (GTR, 1907).</p>

<p>Plate 29: View of the stone arch culvert.</p>

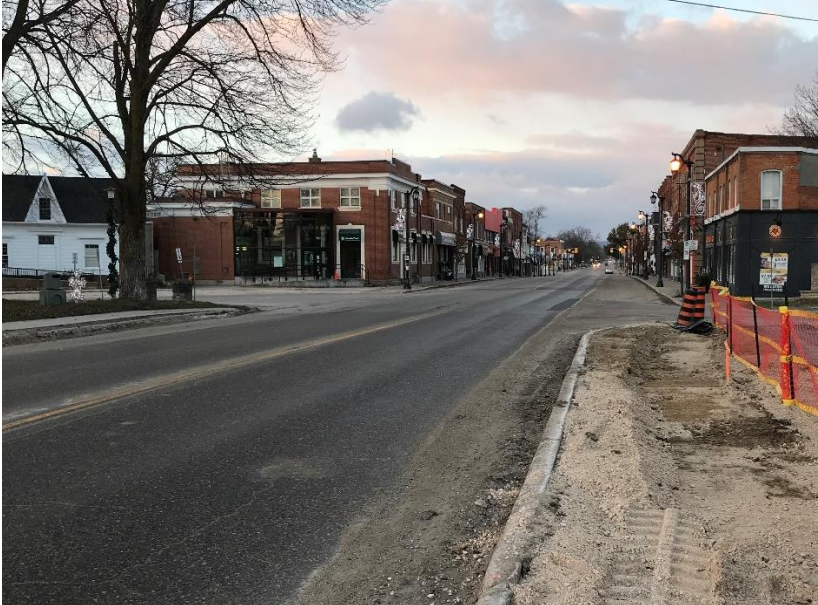
Feature I.D.	Type of Property	Address or Location	Heritage Status and Recognition	Description of Property and Known or Potential C.H.V.I.	Photographs/ Digital Image
C.H.L. 1	Streetscape	Main Street from Huron Street to Perry Street, Stayner	Potential C.H.L. – Identified during desktop review and/or field review  Identified during field review	The Stayner downtown streetscape includes the properties located along both sides of Main Street from Huron Street to Perry Street. The potential heritage attributes include the collection of commercial properties, residences, and Station Park which reflect the nineteenth century development of the commercial core of this rural town. The 1871 map (Figure 3) depicts Main Street as a historically surveyed roadway within the Village of Stayner.

<p data-bbox="2107 971 2697 1003">Plate 30: View of Main Street in Stayner.</p>
C.H.L. 2	Farmscape	5583 Concession 9 Sunnidale	Potential C.H.L. – Identified during desktop review and/or field review  Identified during a review of Google Streetview	The farmscape is located at the southwestern corner of the intersection of Concession 9 Sunnidale and Sideroad 3/4 Sunnidale. The potential heritage attributes include the one-and-a-half storey brick residence, barns and outbuildings, long tree-lined driveway, and active agricultural fields. The 1940 and 1941 topographic map (Figure 5) depicts a residence and barn in the vicinity of the extant structures.

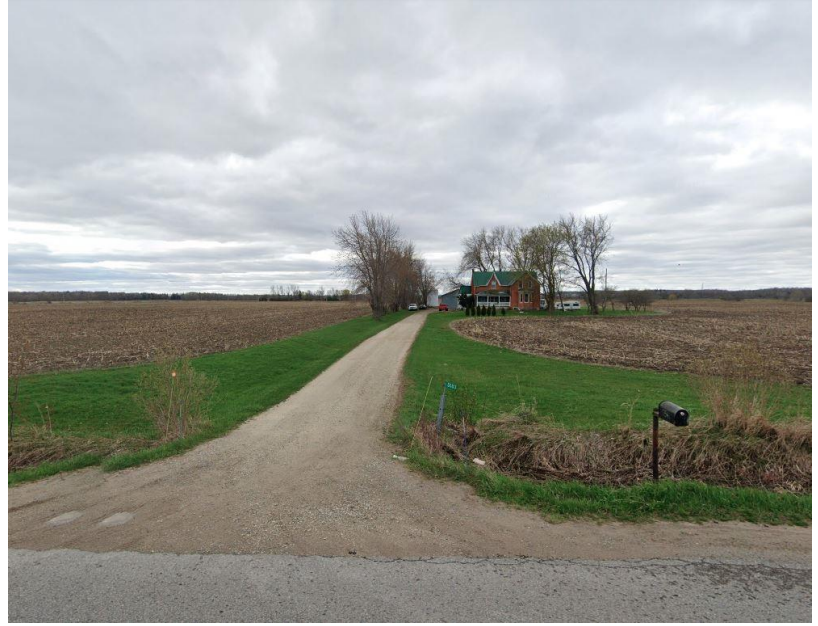
<p data-bbox="2107 1616 2884 1681">Plate 31: View of the property at 5583 Concession 9 Sunnidale (Google Streetview 2021).</p>

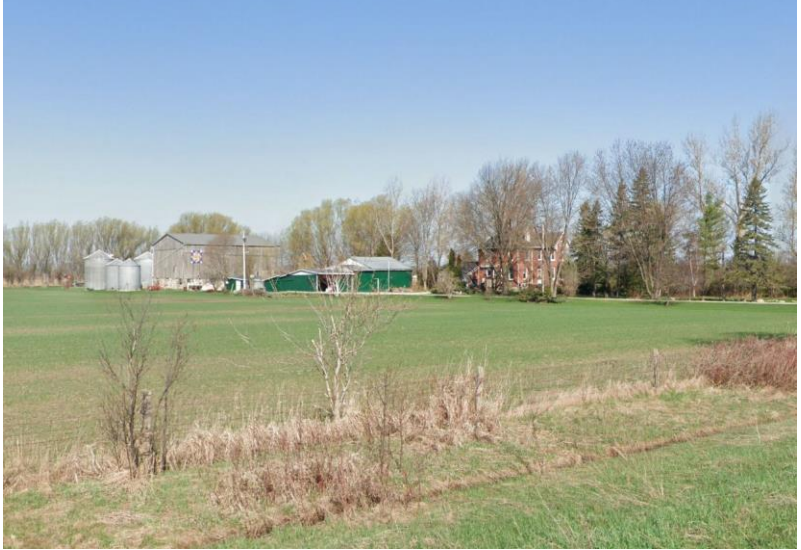
Feature I.D.	Type of Property	Address or Location	Heritage Status and Recognition	Description of Property and Known or Potential C.H.V.I.	Photographs/ Digital Image
C.H.L. 3	Farmscape	1724 Sideroad 3/4 Sunnidale	<p>Potential C.H.L. – Identified during desktop review and/or field review</p> <p>Identified during a review of Google Streetview</p>	<p>The farmscape is located on the western side of Sideroad 3/4 Sunnidale to the south of Concession 9 Sunnidale. The potential heritage attributes include the two-and-a-half storey brick residence, barns and outbuildings, the long tree-lined driveway, and active agricultural fields. The 1940 and 1941 topographic map (Figure 5) depicts a residence and barn in the vicinity of the extant structures.</p>

<p>Plate 32: View of the property at 1724 Sideroad 3/4 Sunnidale (Google Streetview 2021).</p>
C.H.L. 4	Farmscape	5497 Concession 9 Sunnidale	<p>Potential C.H.L. – Identified during desktop review and/or field review</p> <p>Identified during a review of Google Streetview</p>	<p>The farmscape is located at the southeastern corner of the intersection of Concession 9 Sunnidale and Sideroad 3/4 Sunnidale. The potential heritage attributes include the two storey brick residence, barns and outbuildings, long driveway, and active agricultural fields. The 1940 and 1941 topographic map (Figure 5) depicts a residence and barn in the vicinity of the extant structures.</p>

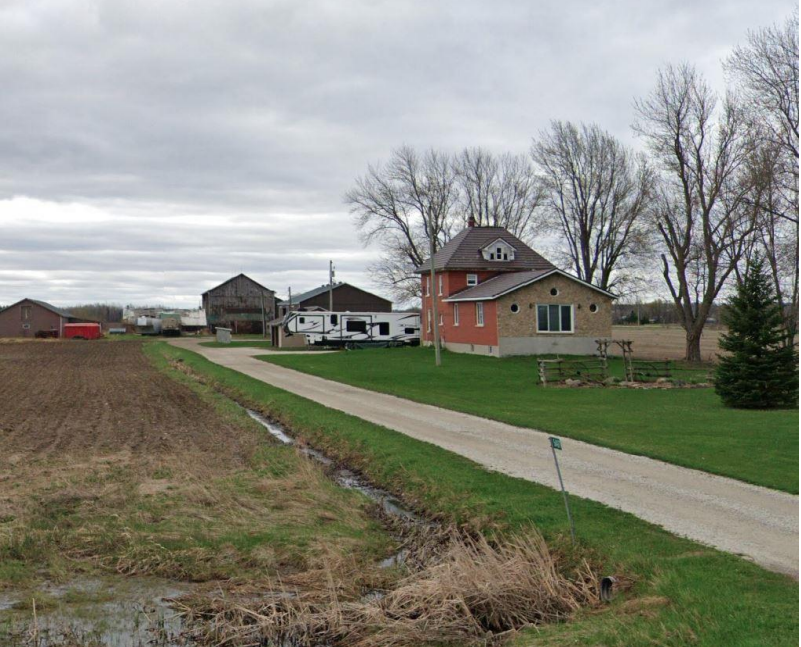
<p>Plate 33: View of the property at 5497 Concession 9 Sunnidale (Google Streetview 2021).</p>

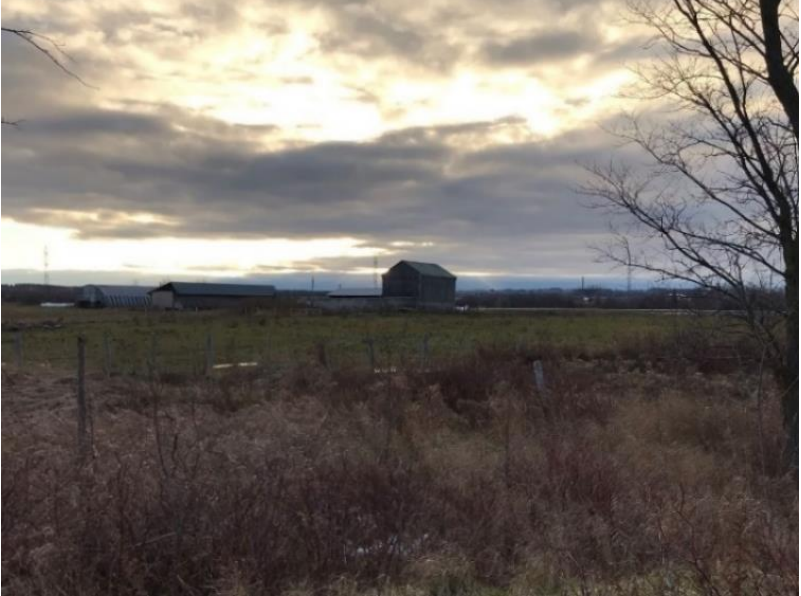
Feature I.D.	Type of Property	Address or Location	Heritage Status and Recognition	Description of Property and Known or Potential C.H.V.I.	Photographs/ Digital Image
C.H.L. 5	Farmscape	1885 Sideroad 3/4 Sunnidale	<p>Potential C.H.L. – Identified during desktop review and/or field review</p> <p>Identified during a review of Google Streetview</p>	<p>The farmscape is located at the northeastern corner of the intersection of Sideroad 3/4 Sunnidale and Concession Road 7 Sunnidale. The potential heritage attributes include the plank barn with concrete block foundations and active agricultural fields. The 1940 and 1941 topographic map (Figure 5) depicts a barn in the vicinity of the extant structure.</p>

<p>Plate 34: View of the property at 1885 Sideroad 3/4 Sunnidale.</p>
C.H.L. 6	Farmscape	5546 Concession Road 6 Sunnidale	<p>Potential C.H.L. – Identified during desktop review and/or field review</p> <p>Identified during a review of Google Streetview</p>	<p>The farmscape is located on the north side of Concession Road 6 Sunnidale to the east of Sideroad 6/7 Sunnidale. The potential heritage attributes include the one-and-a-half storey brick residence, barns and outbuildings, long driveway, and active agricultural fields. The 1940 and 1941 topographic map (Figure 5) depicts a residence and barn in the vicinity of the extant structures and a long drive leading to the buildings.</p>

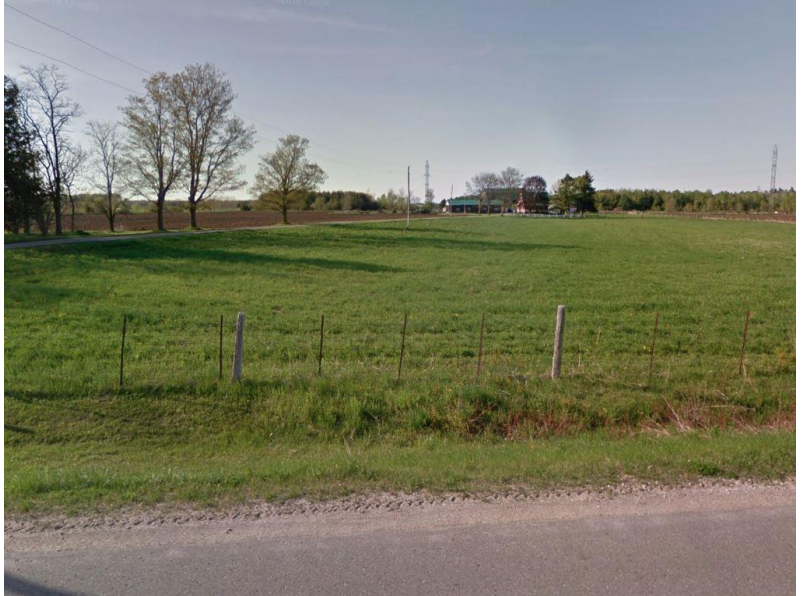
<p>Plate 35: View of the property at 5546 Concession 6 Sunnidale (Google Streetview 2018).</p>

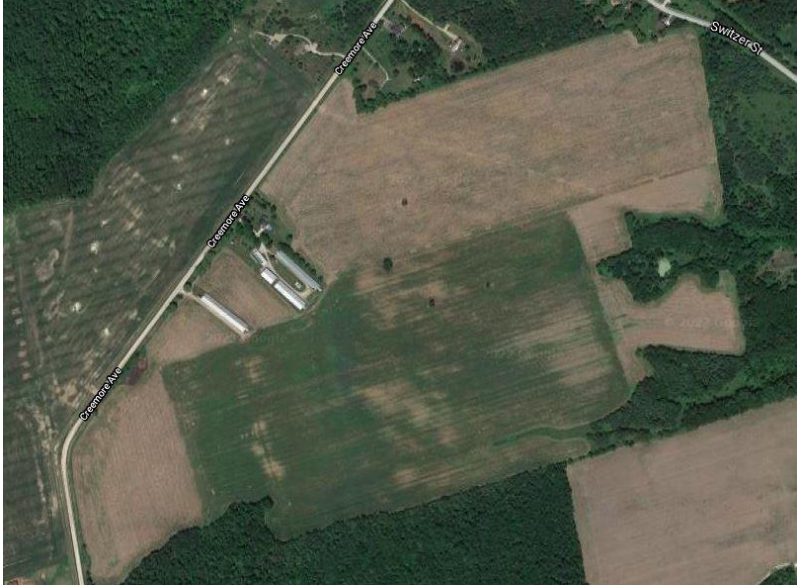
Feature I.D.	Type of Property	Address or Location	Heritage Status and Recognition	Description of Property and Known or Potential C.H.V.I.	Photographs/ Digital Image
C.H.L. 7	Farmscape	2829 Creemore Avenue	Potential C.H.L. – Identified during desktop review and/or field review  Identified during a review of Google Streetview	The farmscape is located along the southern side of Creemore Avenue to the west of Switzer Street. The potential heritage attributes include the residence, barns, mature vegetation, driveway, and active agricultural fields. The 1940 and 1941 topographic map (Figure 5) depicts a residence and barn in the vicinity of the extant structures.

<p data-bbox="2116 949 2769 1024">Plate 36: Aerial view of the property at 2829 Creemore Avenue (Google Earth 2022).</p>
C.H.L. 8	Farmscape	2630 9/10 Sideroad Sunnidale	Potential C.H.L. – Identified during desktop review and/or field review  Identified during a review of Google Streetview	The farmscape is locate at the northwest corner of the intersection of 9/10 Sideroad Sunnidale and Switzer Street. The potential heritage attributes include the single-storey stone residence, barn and outbuildings, paddock, mature vegetation, and active agricultural fields. The 1940 and 1941 topographic map (Figure 5) depicts a residence in the vicinity of the extant structure.

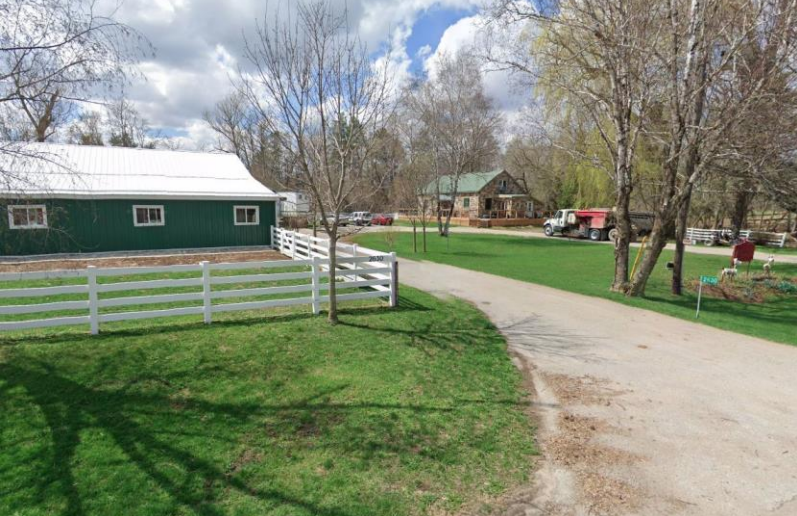
<p data-bbox="2116 1534 2874 1608">Plate 37: View of the property at 2630 9/10 Sideroad Sunnidale (Google Streetview 2021).</p>

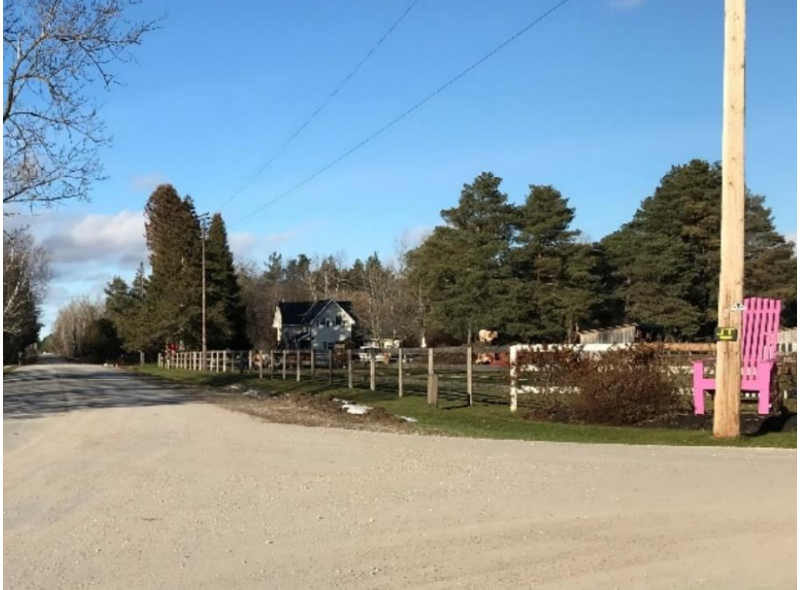
Feature I.D.	Type of Property	Address or Location	Heritage Status and Recognition	Description of Property and Known or Potential C.H.V.I.	Photographs/ Digital Image
C.H.L. 9	Farmscape	2629 9/10 Sideroad Sunnidale	<p>Potential CHL – Identified during desktop review and/or field review</p> <p>Identified during a review of Google Streetview</p>	<p>The farmscape is locate at the northeast corner of the intersection of 9/10 Sideroad Sunnidale and Switzer Street. It is also north of Concession Road 5 Sunnidale. The potential heritage attributes include the one-and-a-half storey frame residence, barn and outbuildings, paddocks, and mature vegetation. The 1940 and 1941 topographic map (Figure 5) depicts a residence in the vicinity of the extant structure.</p>

<p>Plate 38: View of the property at 2629 9/10 Sideroad Sunnidale.</p>
C.H.L. 10	Streetscape	County Road 9 from Switzer Street to the former rail line, New Lowell	<p>Potential C.H.L. – Identified during desktop review and/or field review</p> <p>Identified during field review</p>	<p>The New Lowell streetscape includes the properties along the southern side of County Road 9 to approximately 96 metres east of the former rail line and includes some properties along Elgin Street. The potential heritage attributes include the collection of residential and commercial properties which reflect the nineteenth-century village setting of this streetscape. The 1871 map (Figure 3) depicts the community of New Lowell with County Road 9 as a historically surveyed roadway.</p>

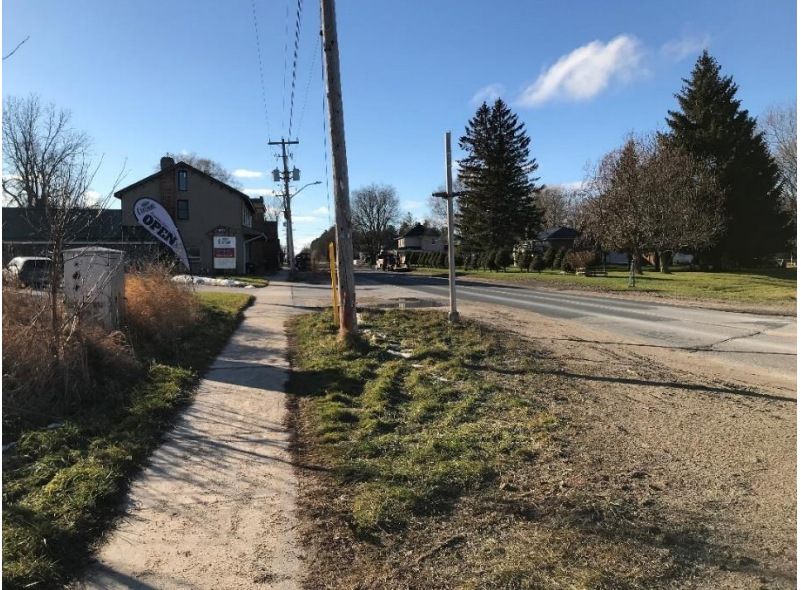
<p>Plate 39: View of County Road 9 in New Lowell.</p>

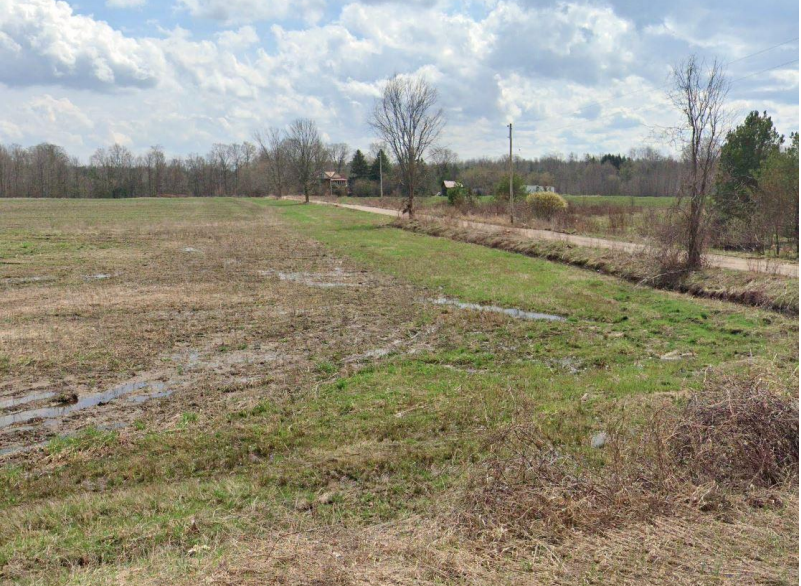
Feature I.D.	Type of Property	Address or Location	Heritage Status and Recognition	Description of Property and Known or Potential C.H.V.I.	Photographs/ Digital Image
C.H.L. 11	Farmscape	5107 County Road 9	<p>Potential C.H.L. – Identified during desktop review and/or field review</p> <p>Identified during a review of Google Streetview</p>	<p>The farmscape is located at the southwestern corner of the intersection of County Road 9 and Sideroad 12/13 Sunnidale. The potential heritage attributes include the two-and-a-half storey brick residence, barn, long driveway, and active agricultural fields. The 1940 and 1941 topographic map (Figure 5) depicts a residence and barn in the vicinity of the extant structures and a long drive leading to the buildings.</p>

<p>Plate 40: View of the property at 5107 County Road 9 (Google Streetview 2021).</p>
C.H.L. 12	Farmscape	2964 Sideroad 12/13 Sunnidale	<p>Potential C.H.L. – Identified during desktop review and/or field review</p> <p>Identified during a review of Google Streetview</p>	<p>The farmscape is located on the western side of Sideroad 12/13 Sunnidale to the south of County Road 9. The potential heritage attributes include the residence, barn and outbuildings, long tree-lined driveway, and active agricultural fields. The 1940 and 1941 topographic map (Figure 5) depicts a residence and barn in the vicinity of the extant structures.</p>
