# Cultural Heritage Report: Existing Conditions

## Barrie Collingwood Railway Active Transportation Trail Municipal Class Environmental Assessment

### County of Simcoe, Ontario

#### Draft Report

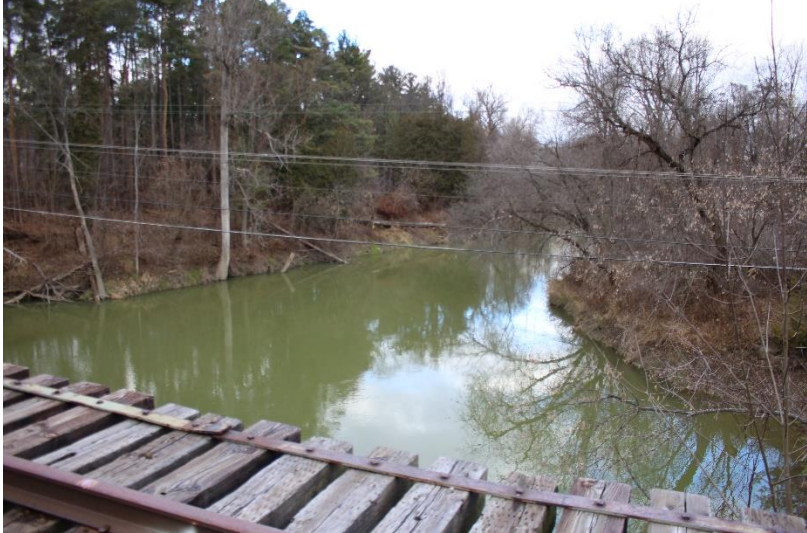
Feature I.D.	Type of Property	Address or Location	Heritage Status and Recognition	Description of Property and Known or Potential C.H.V.I.	Photographs/ Digital Image
C.H.L. 15	Watercourse	Nottawasaga River	<p>Potential C.H.L. – Identified during desktop review and/or field review</p> <p>Identified during field review</p>	<p>The Nottawasaga River flows in a general meandering north-south orientation transecting the study area. The Nottawasaga Valley Watershed is shaped like a bowl with the Niagara Escarpment, the Oak Ridges Moraine, and the Simcoe Uplands/Oro Moraine representing the height of land along the edges of the bowl. Streams arise from these high areas and flow down slope into the Simcoe Lowlands. These lowlands extend to Wasaga Beach and Collingwood (a “chip” at the edge of the bowl) which allows the Nottawasaga River and Blue Mountain streams to reach Georgian Bay (Nottawasaga Valley &amp; Conservation Authority, 2018).</p> <p>The Nottawasaga River would have been used as an Indigenous travel corridor and as a source for resource acquisition. The subsequent Europeans to arrive would have followed these Indigenous pathways and set up trading posts at locations along these well-traveled routes. The Nottawasaga River also played a strategic role in the War of 1812 and facilitated troop and supply movements between Georgian Bay and Lake Ontario.</p>

<p>Plate 44: View of the Nottawasaga River.</p>
