THURBER ENGINEERING LTD.

**ASSESSMENT OF PAST USES REPORT
OLD FORT ROAD BRIDGE REPLACEMENT
SIMCOE COUNTY
ONTARIO**

Date: February 2023

File: 35527

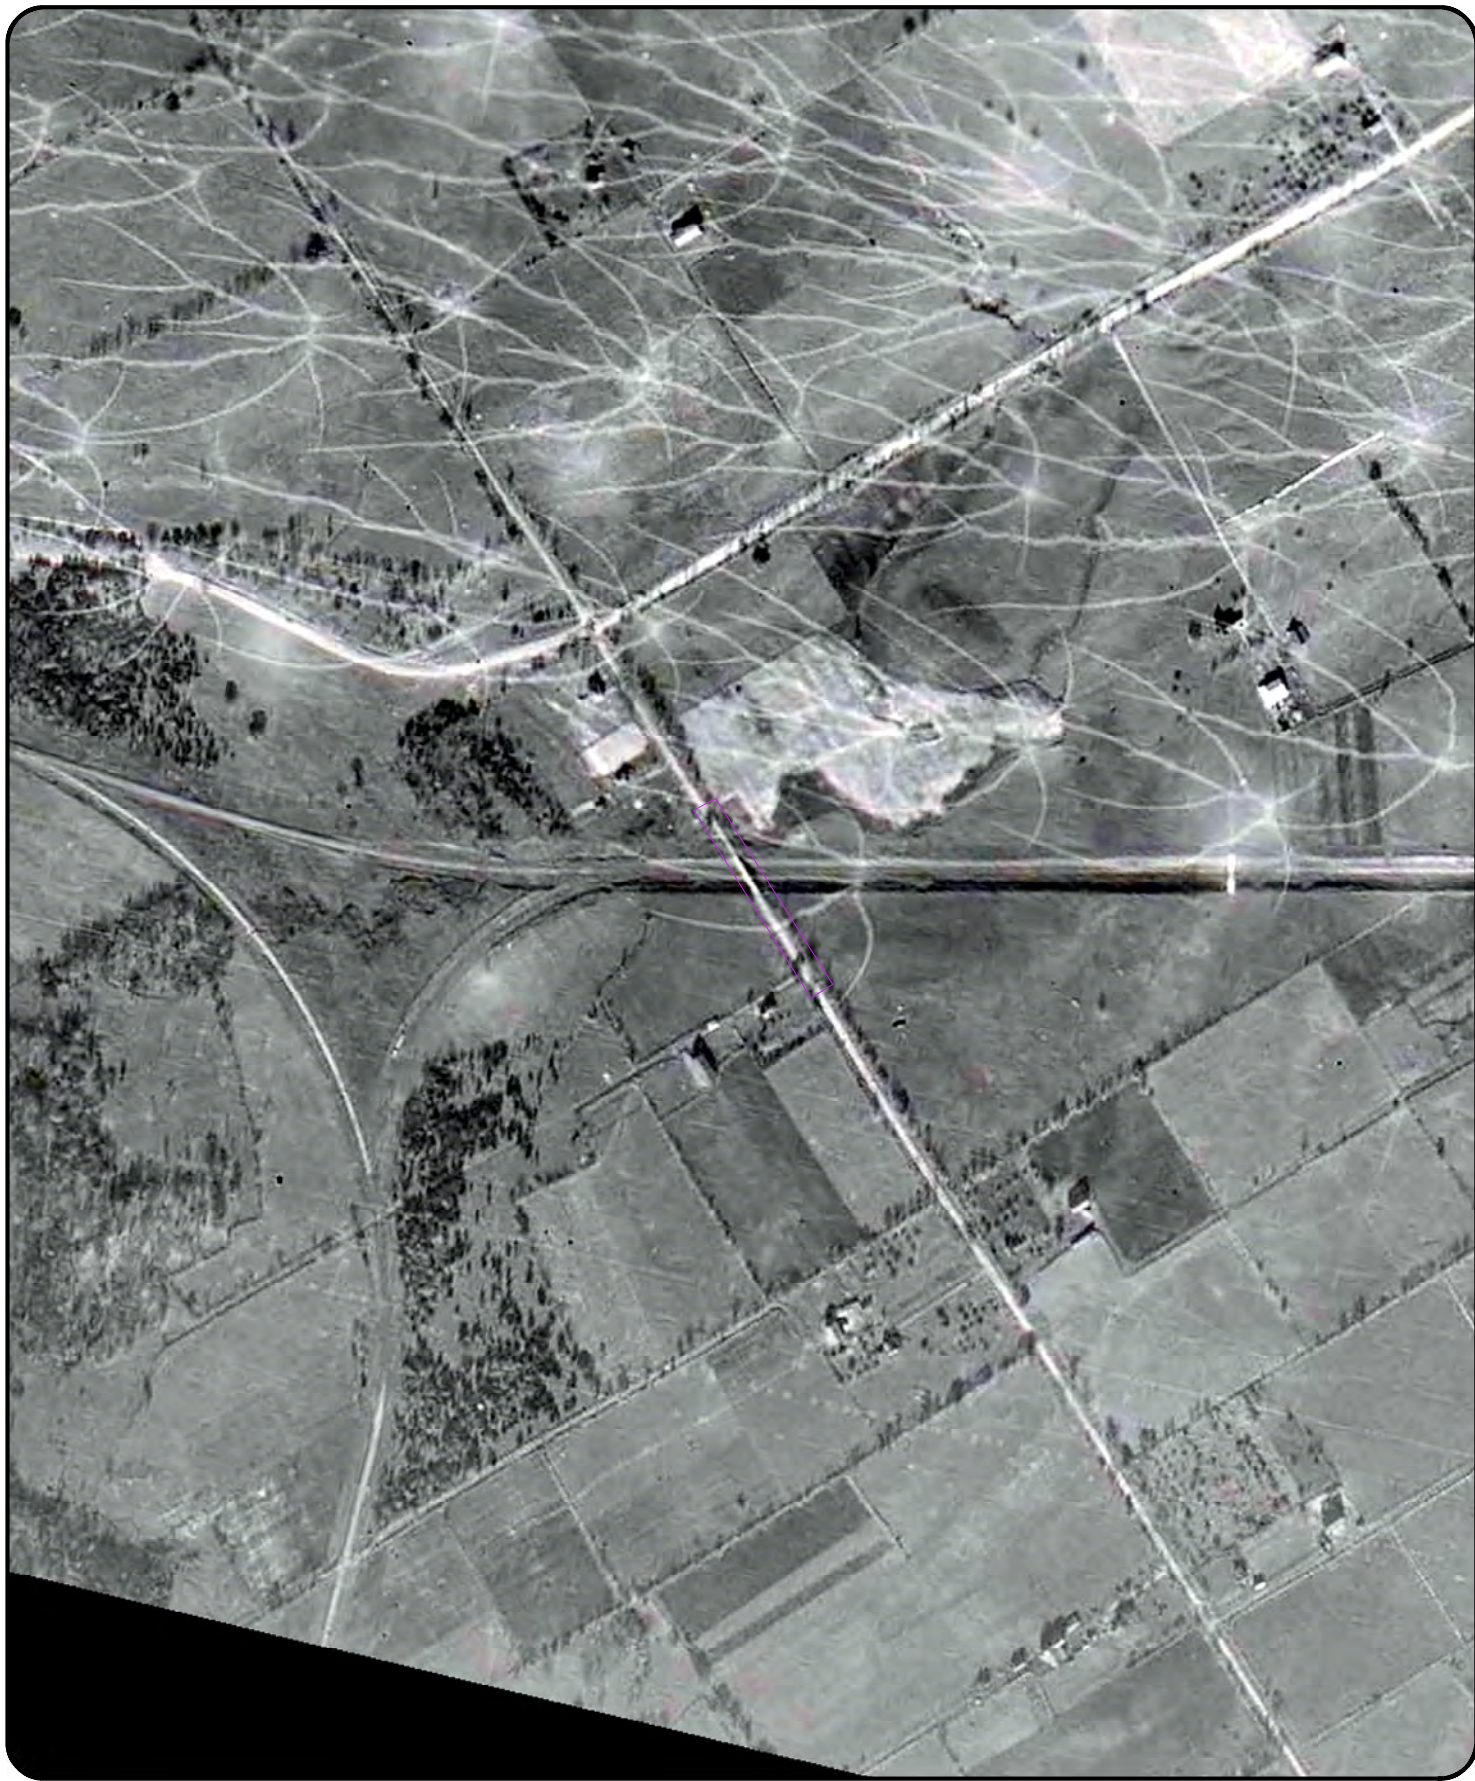
Year: 1930
Source: NAPL
Map Scale: 1: 10000
Comments: Best Copy Available

A review of the earliest available records (1930 Aerial Photograph) showed the presence of a rural road and bridge that extended over the (CN) railway that appeared to have a similar configuration to the present-day condition. On this basis, the first developed use of the Project Area was identified as community (i.e., the road) as of 1930.

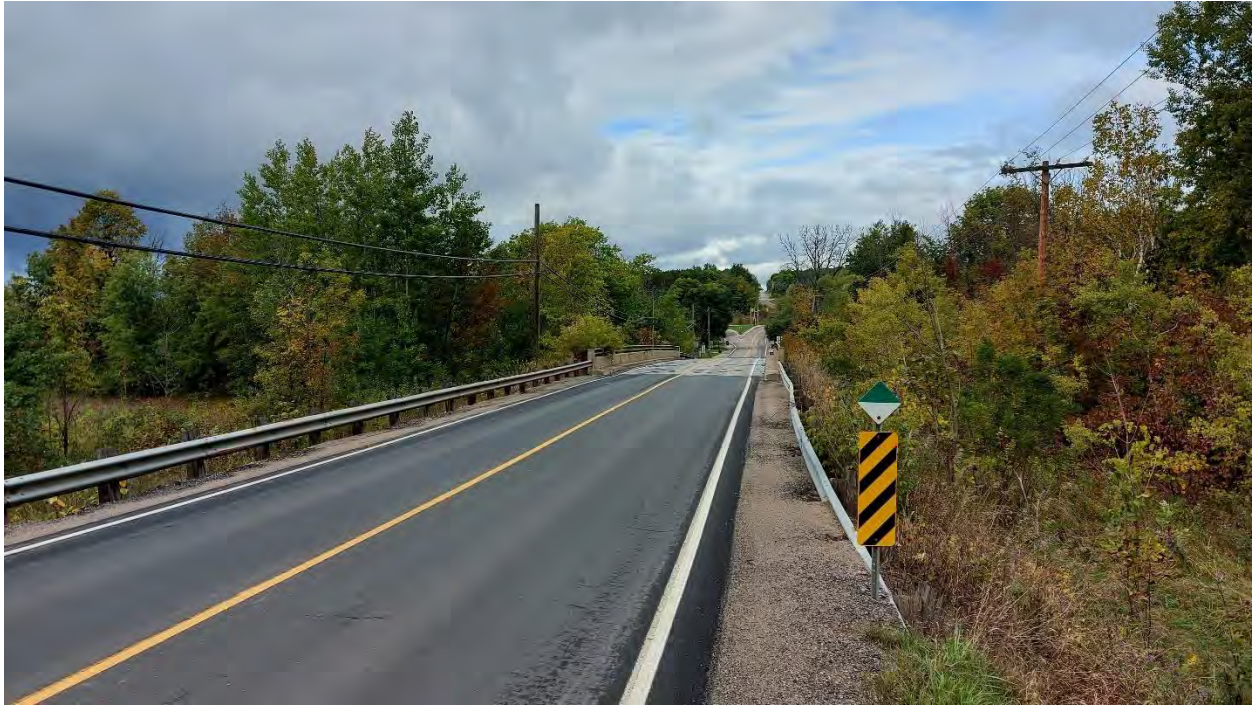
Photo 1: View of Old Fort Road, 20m south of the bridge, facing north.

No staining of soil or ground cover was observed within the Project Area. The paved portions of Old Fort Road and the TransCanada trail appeared in good condition with no significant staining observed. The roadway appeared to be constructed on fill material, however no staining or odours were observed on and near areas of fill that were exposed during the Site Reconnaissance. Vegetation appeared to be healthy or dormant during the Site Reconnaissance.

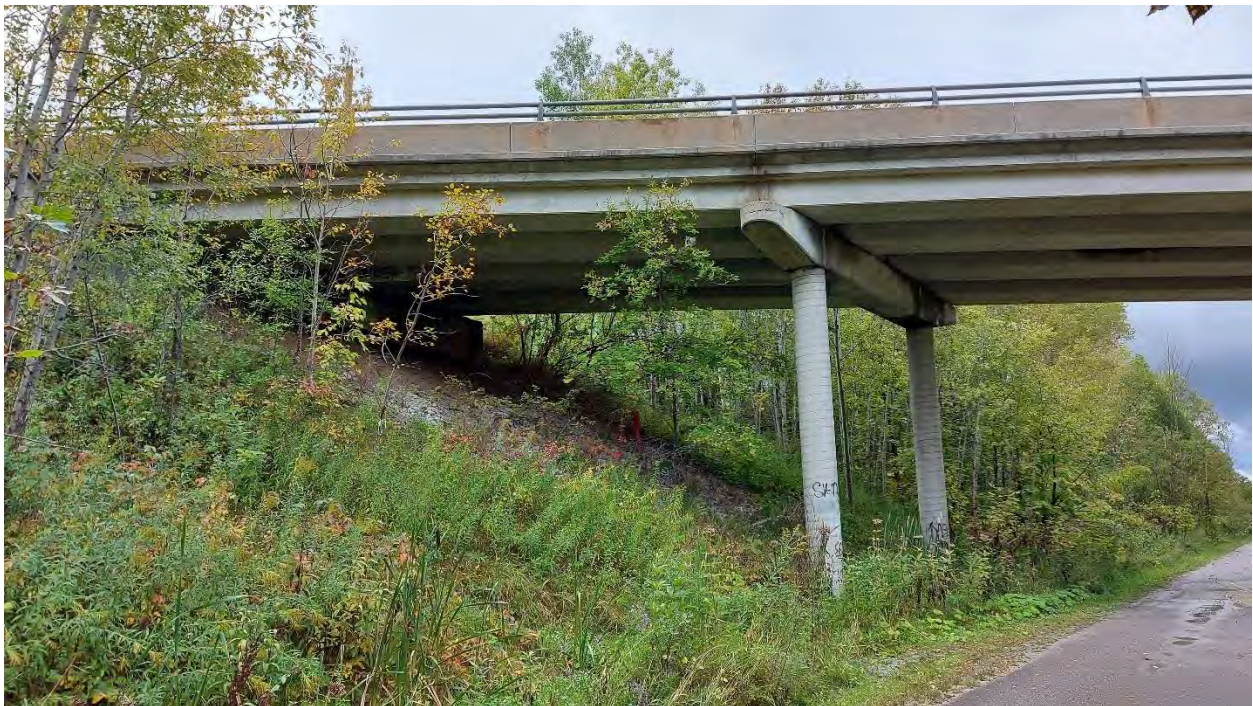
Photo 2: South bridge abutment/embankment, from the TransCanada trail, facing west.

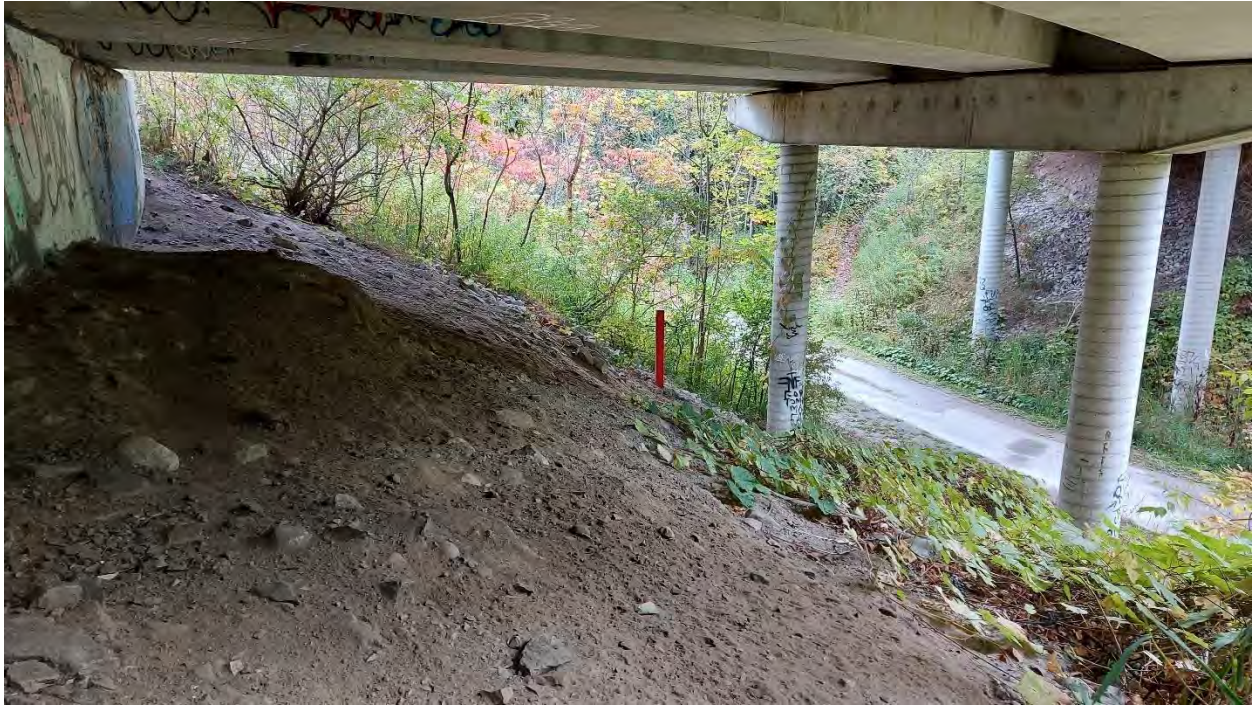
Photo 3: Underside of the bridge, view of the north embankment, facing southeast.

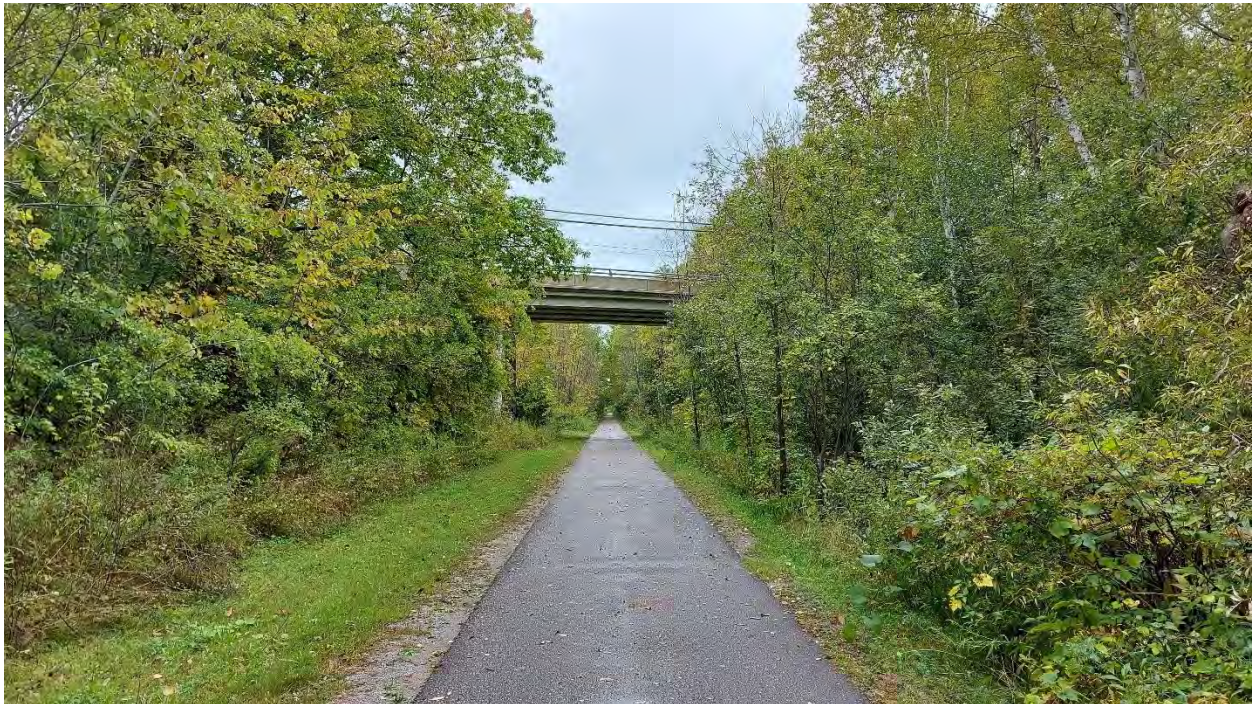
Photo 4: View of the Project Area from the TransCanada trail, facing east towards the bridge.

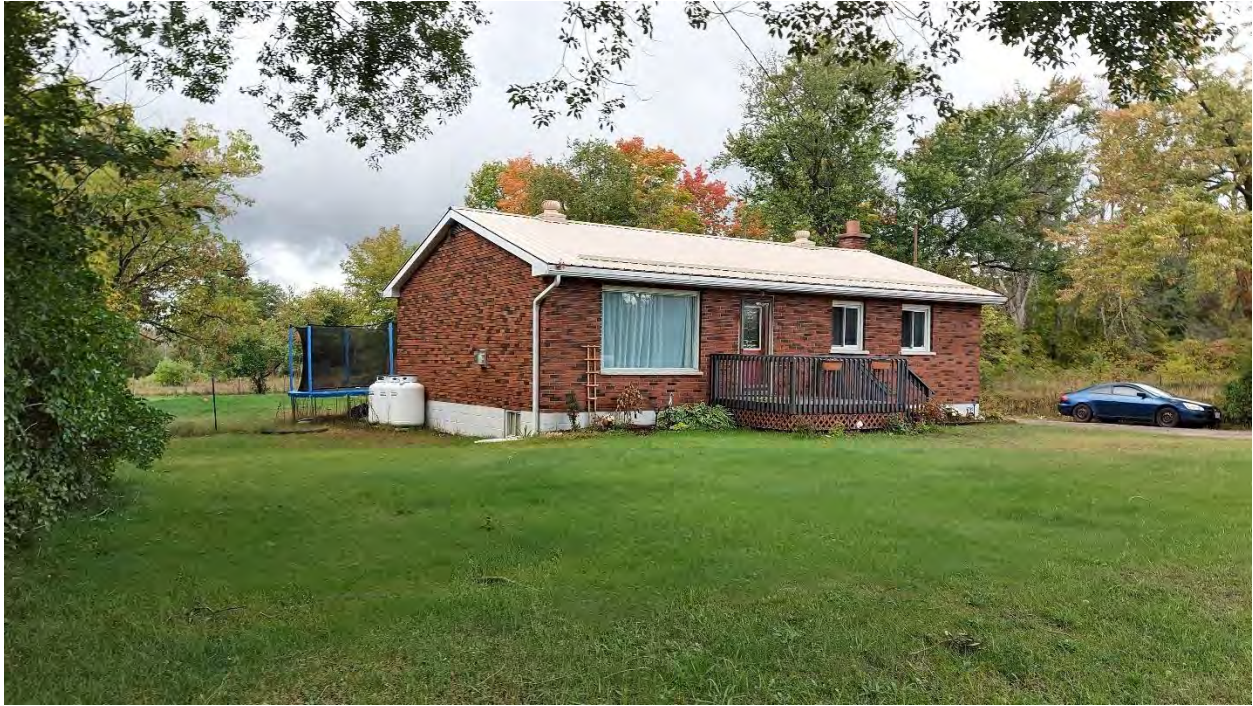
Photo 5: 2852 Old Fort Road residential home, propane heating tanks typical of the houses in the APU Study Area are visible.

No above ground or underground tanks were observed within the Project Area during the Site Reconnaissance, however, multiple propane tanks for heating were observed on the exterior of a number of homes (Photos 5 and 6).

Topic	Description
Above-ground Storage Tanks (ASTs)	Propane ASTs were observed at multiple residential properties adjacent to the Project Area: <ul style="list-style-type: none"> • 2852 Old Fort Road (Photo 5). • 2855 Old Fort Road (Photo 6).
Underground Storage Tanks (USTs) or Evidence of USTs	None identified.
Product Piping	None identified.
Drums or Totes	None identified.
Water Supply	Several domestic water supply well records were identified in the historical records, with one well observed during the Site Reconnaissance at 2855 Old Fort Road (Photo 6).
Transformers	Pole-mounted transformers were observed within the Project Area and APU Study Area. No evidence of staining was noted on the observed transformers, or on the poles and ground surface beneath the transformers.
Commercial/Industrial Properties of Environmental Significance	An EcoLog ERIS listing for a pesticide vendor was reported at 2837 Old Fort Road. The address was observed to be adjacent to the Old Fort Trees property and likely associated with the agricultural property. An Ecolog ERIS listing for an autowrecker was reported at 2738 Old Fort Road. The operation was not visible from publicly accessible areas along the roadway. Review of the aerial photos show that the operations on the property are beyond a treeline 70 m to the west of Old Fort Road.

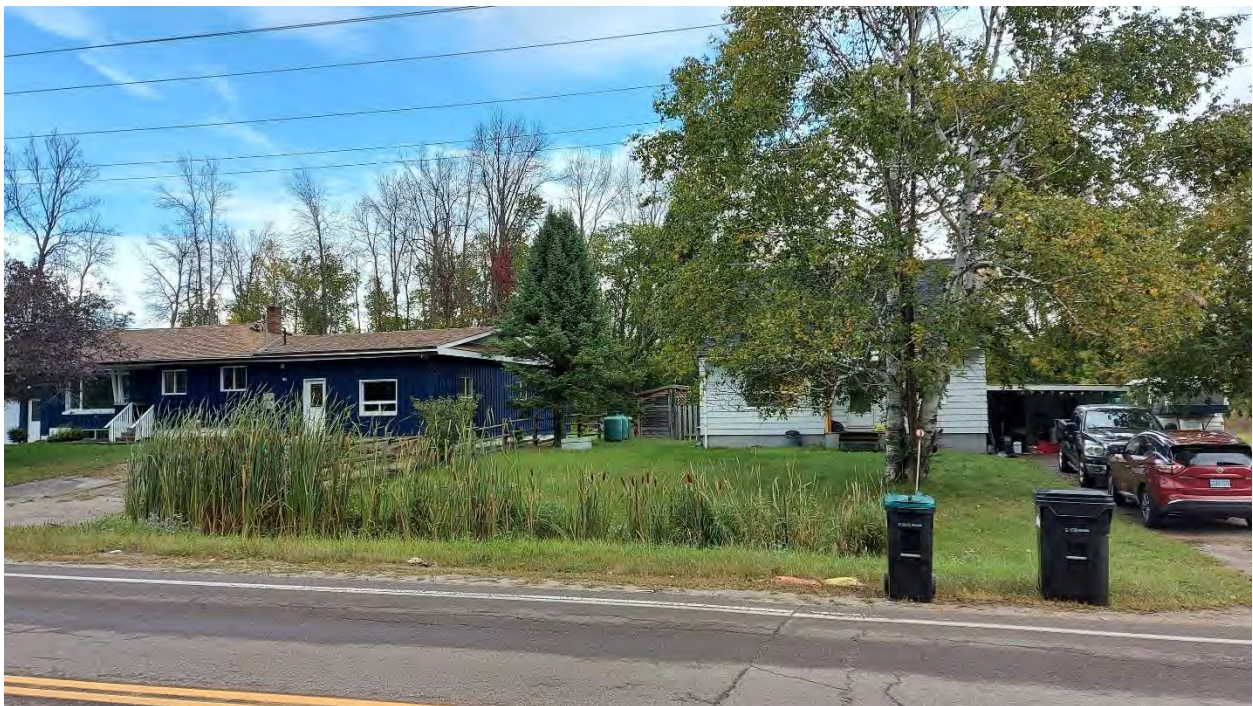
Photo 6: 2849 and 2855 Old Fort Road, propane heating tanks and a dug well are visible.

No private water wells were identified within the Project Area through a search of MECP well records. However, multiple private water wells were reported within the APU Study Area, with the protective cover for a dug or bored well noted at 2855 Old Fort Road (Photo 6). Two monitoring wells were observed beneath the bridge on the north and south embankments. A summary of the well records reviewed was provided in Section 4.b.(v).

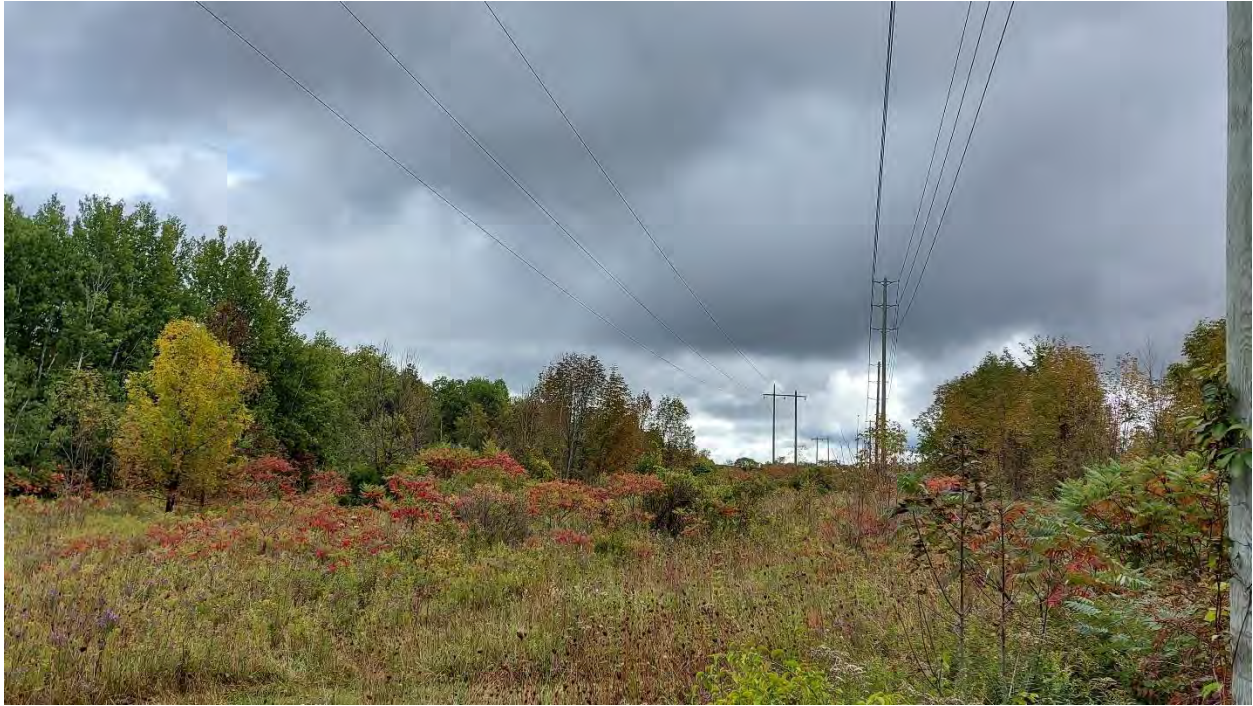
Photo 7: View of a hydro corridor to the south of the TransCanada trail, from Old Fort Road facing east.

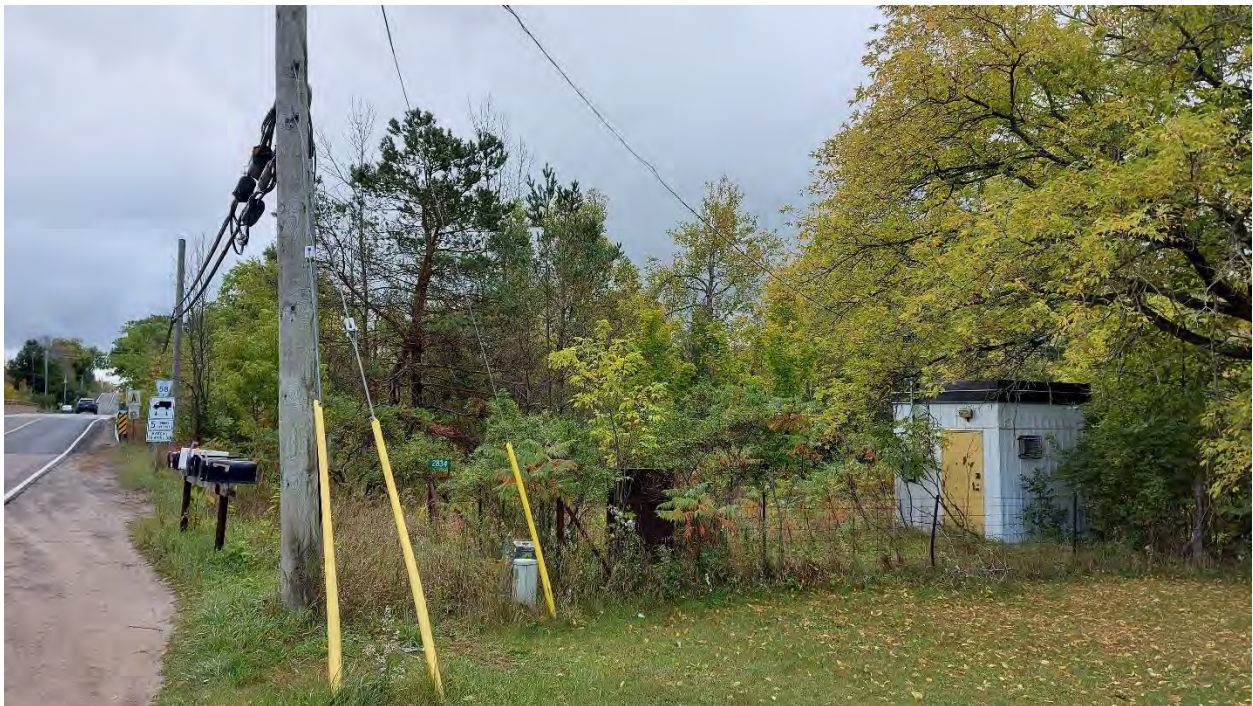
Photo 8: View of Bell telephone junction boxes located on the northwest side of the bridge, facing south.

the bridge where the telephone lines switched from below ground (north of the bridge) to above ground (across and south of the bridge). Pole-mounted transformers were observed within the APU Study Area along Old Fort Road, however, no leaks or staining were observed on the transformers or on the poles and ground surface beneath the transformers.
